Bass Coast Shire Council

BASS COAST AQUATIC & LEISURE CENTRE

TECHNICAL REVIEW

JWC Engineers
MARCH 2018

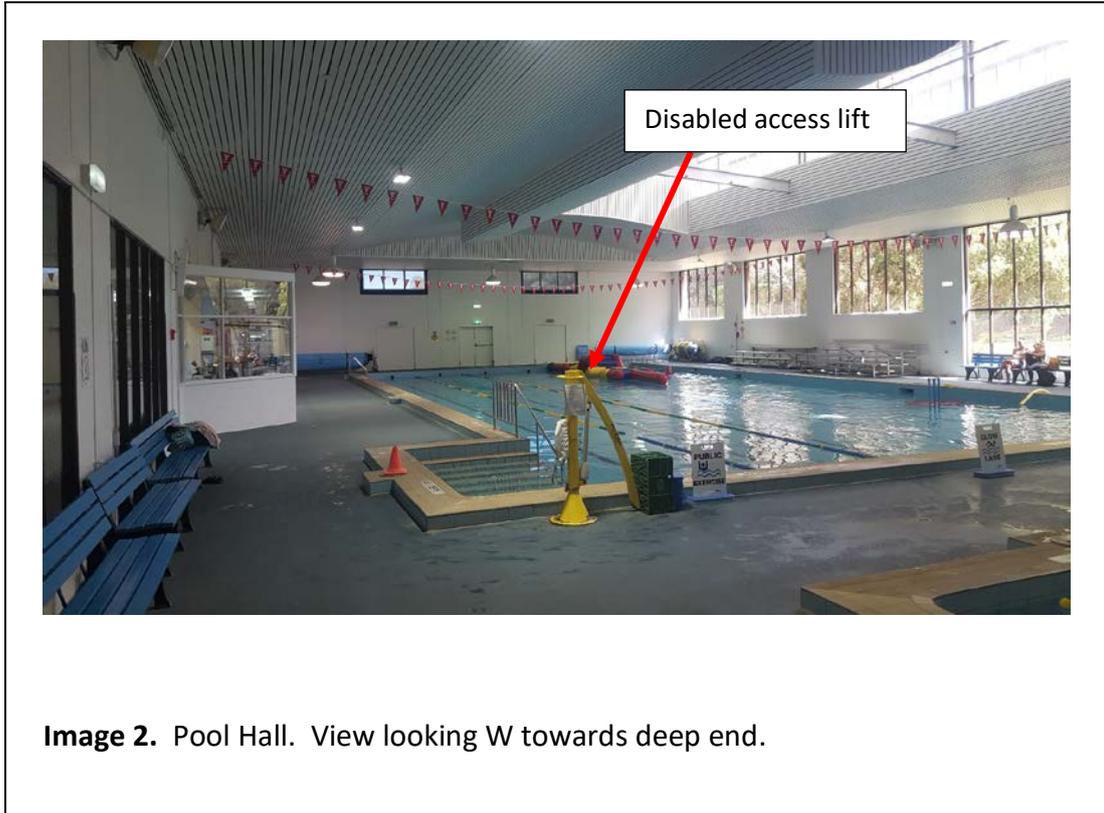
Image 2. Pool Hall. View looking W towards deep end.

There is a recessed step entry at the shallow end with a disabled access lift nearby. See **Image 2 and 4**.

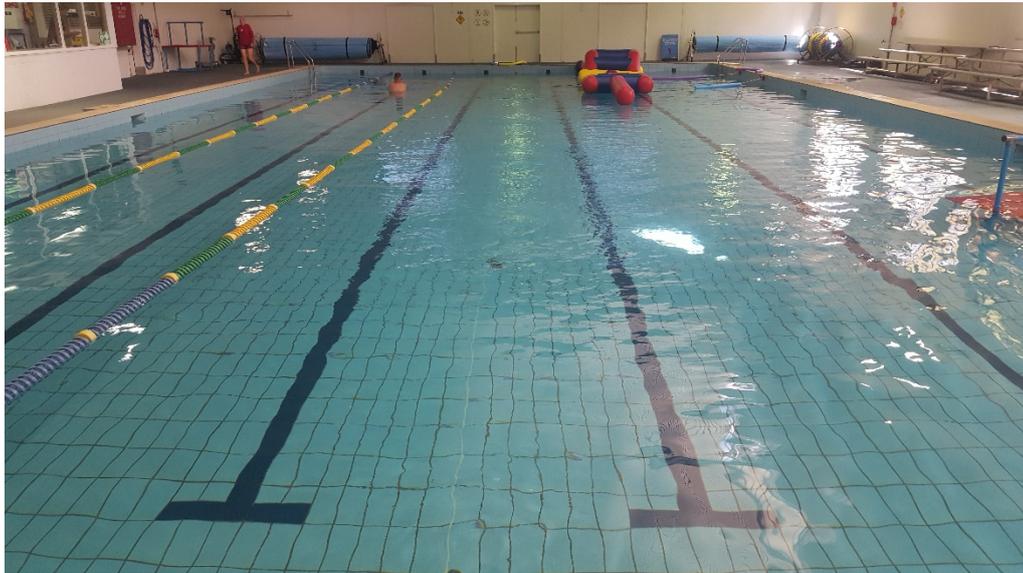
Filtered water return (FWR) back into the pool is via seven (7), by 40mm dia floor nozzles located centrally along the pool. See **Image 5**.

Image 5. Central FWR nozzles along pool centreline. Looking W.

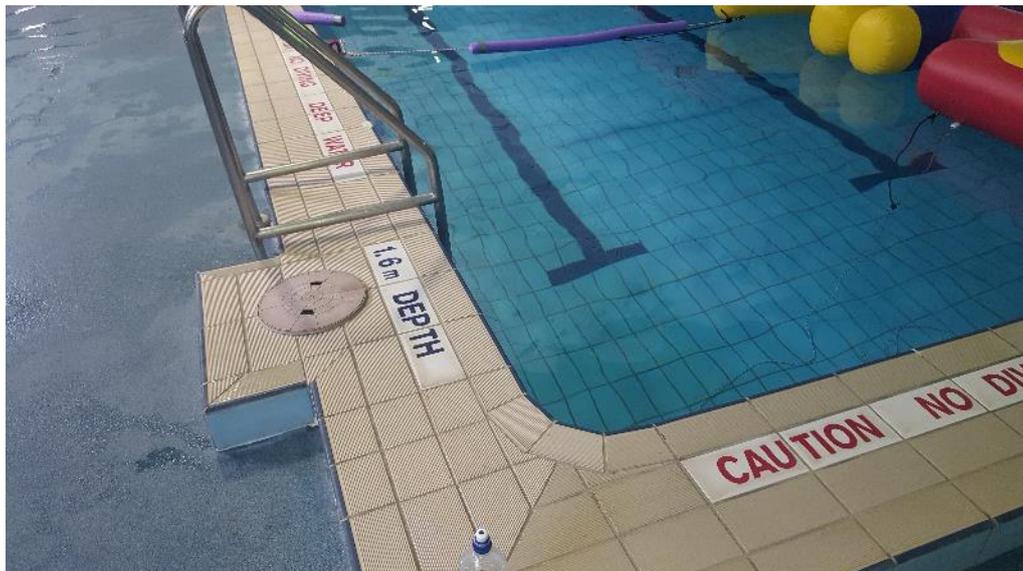
Soiled water collection is via 7 No skimmer boxes. These are not evenly spaced around the pool with 3 on one long side and 4 on the opposite side. See **Images 7 & 8**.

Use of skimmer boxes in public pools was used on a few pools in this era but they are not common. Indeed, the NSW Dept. of Health Swimming Pool and Spa Advisory Document states they are unsuitable for public pools.

They are a constraint on the effectiveness of the water treatment system as they provide only a series of single collection points as opposed a continuous collection system such as a wet deck or gutter.

Image 6. Skimmer box at deep end.

While adequate for this 10-year timeframe, in any major redevelopment of BCALC the replacement of skimmer boxes with a wet deck arrangement is strongly recommended.

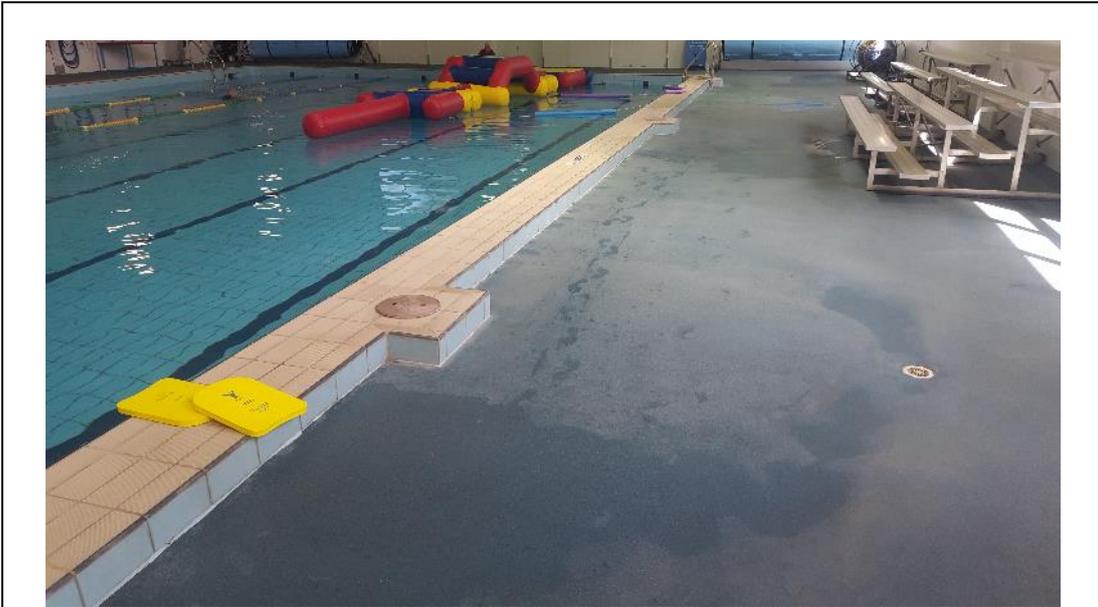
Image 7. Pool concourse on N side. Looking W.

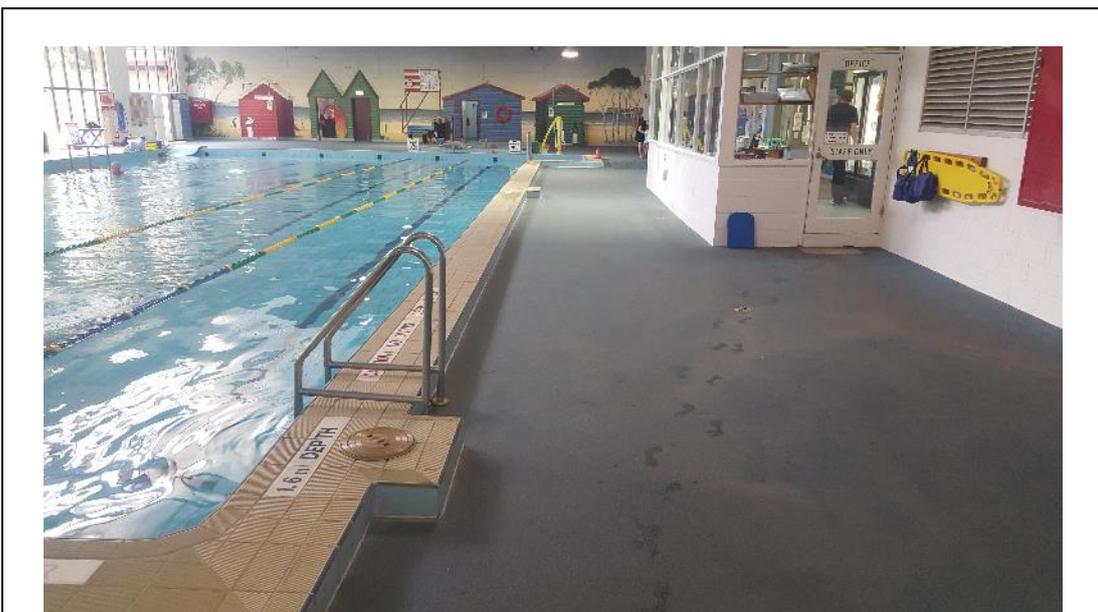
Image 8. Pool concourse on S side. Looking E.

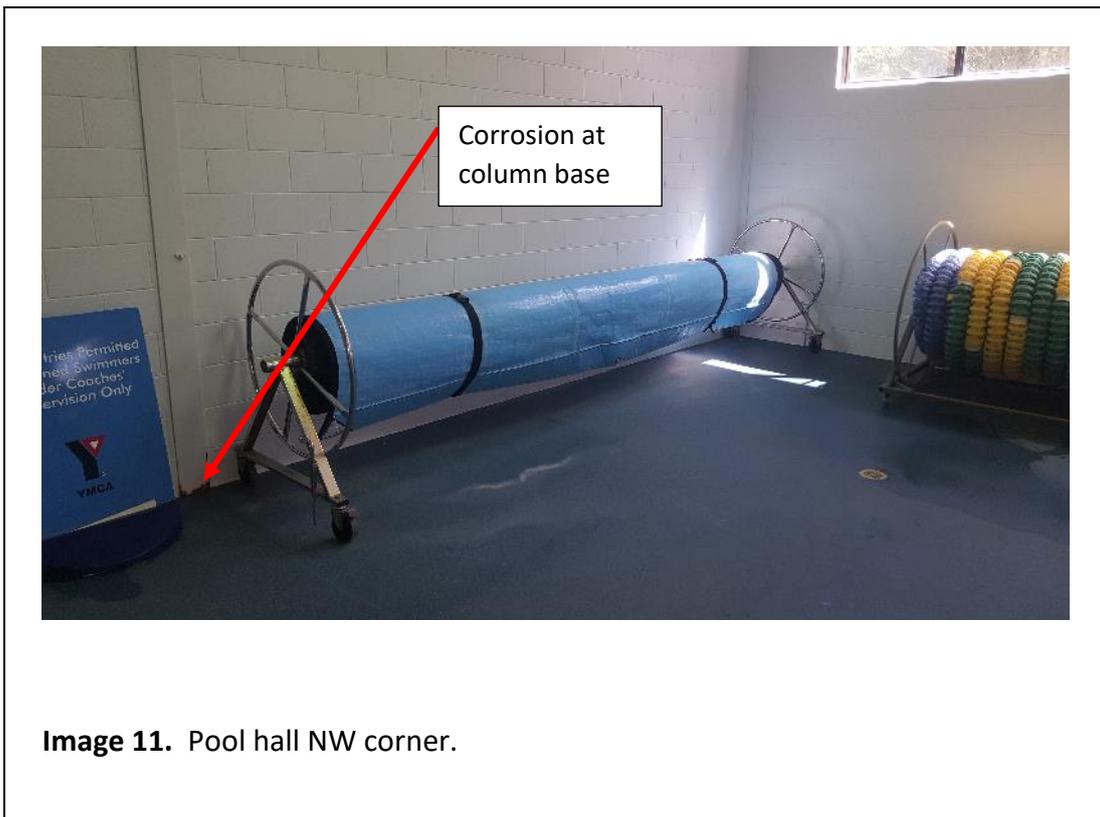
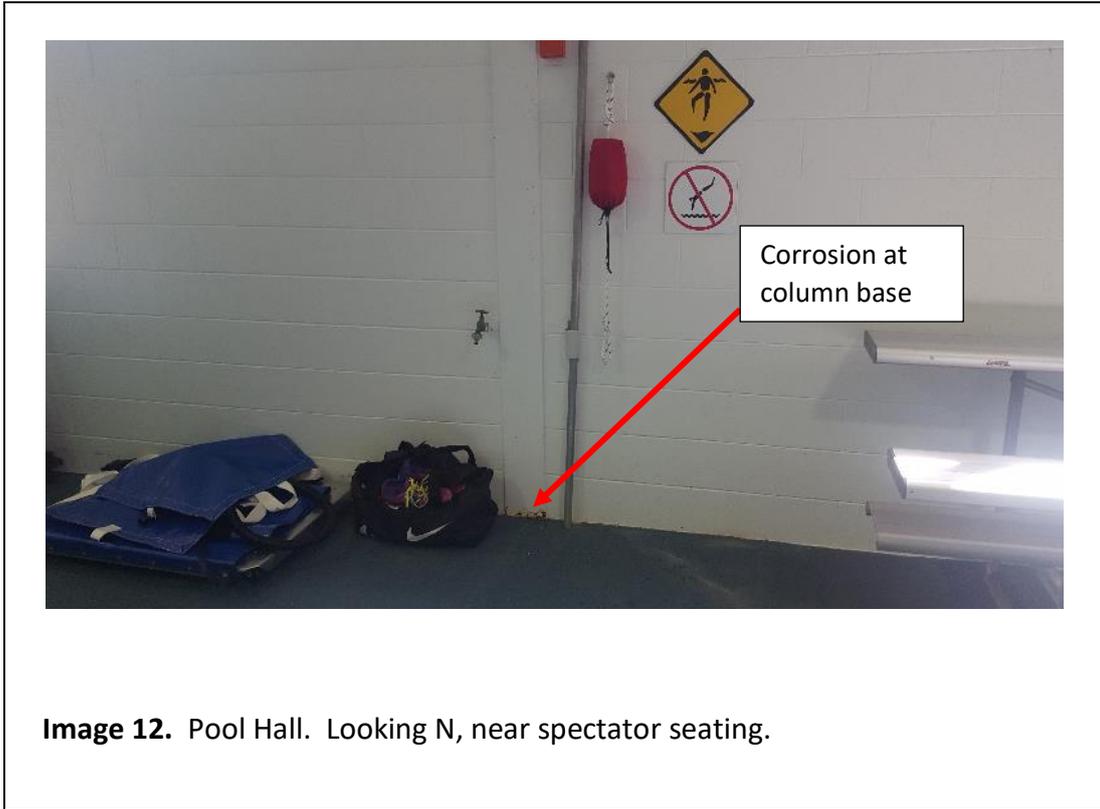
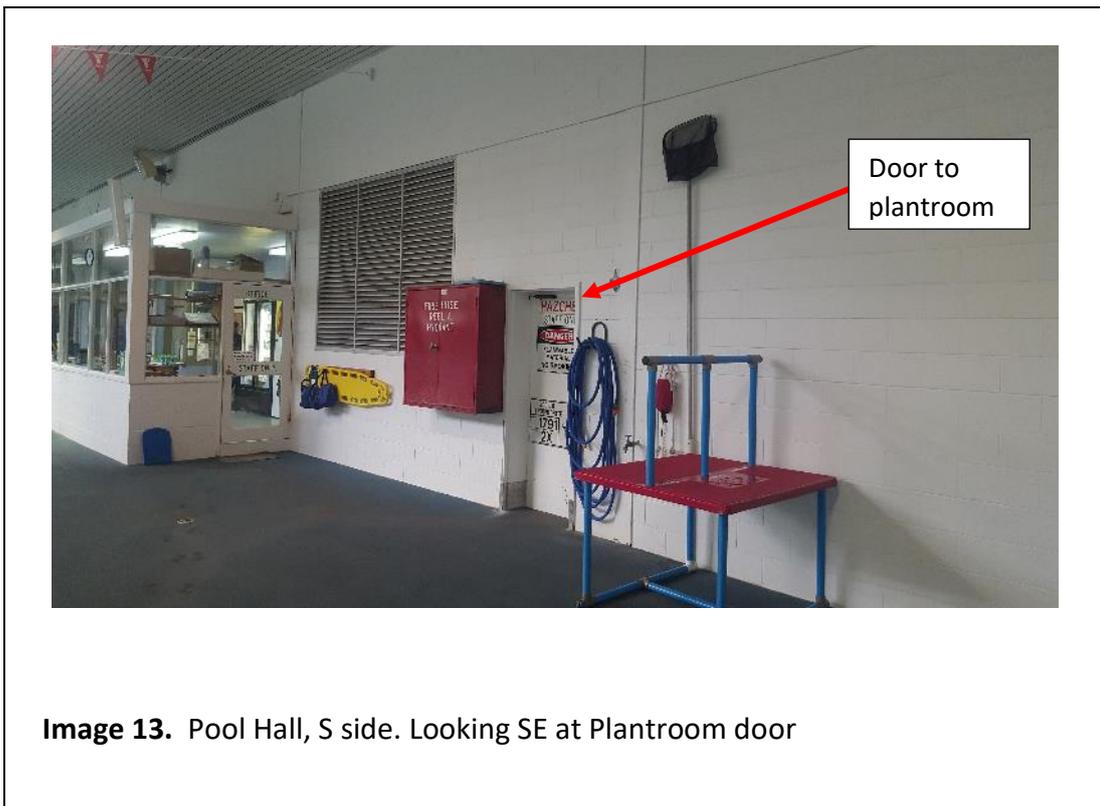
The main steel columns of the pool hall are showing signs of rust where they penetrate through the concourse floor slab. See **Images 11 & 12**. Corrosion at this location is not unusual for pool hall columns and demands attention before the rust starts to penetrate below the slab level and becomes even more difficult to remedy. The corrosion here appears still to be minor to moderate but remedial works and preventative maintenance are recommended to be undertaken in the short term. A proviso is that if the BCALC strategy plan determines that this pool hall will have new structure then there is no longer any need for this short term remedial work.

Remedial works will comprise removal of rust and removal of say top 1cm of slab around the column to check for rust. Given that the masonry walls butt into the columns, severely limiting work access, this will not be a straightforward procedure. A proprietary protective coating should then be applied, and this should be robust and able to accommodate that this is a site application and will need to cover old rust. A mastic-based product may be the most suitable.

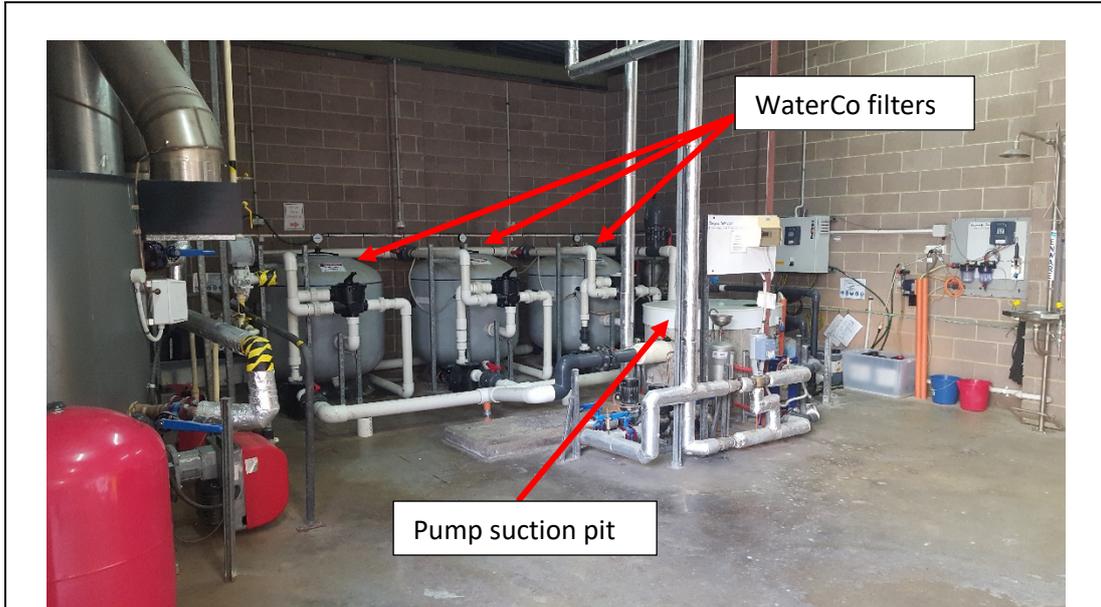
Image 14. General view of plantroom. Looking NW.

A pump suction pit is located central in the plantroom. See **Images 14 & 17**. The soiled water from the skimmer boxes drains here by gravity and the three circulation pumps draw from here to deliver to the treatment system.

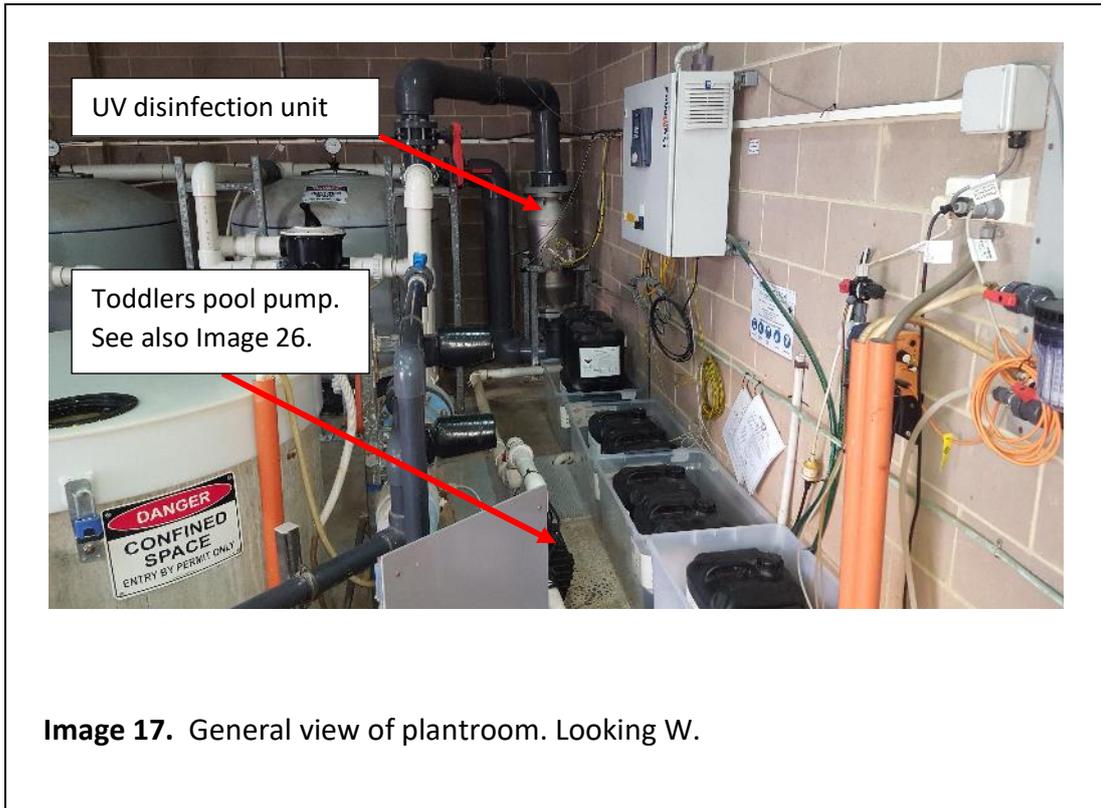
Image 17. General view of plantroom. Looking W.

A new ultraviolet disinfection system was installed about 2 years ago. See **Image 17**. This is reported to have made a significant improvement in the water quality and has helped offset some of the older design issues such as skimmer boxes and low turnover rates.

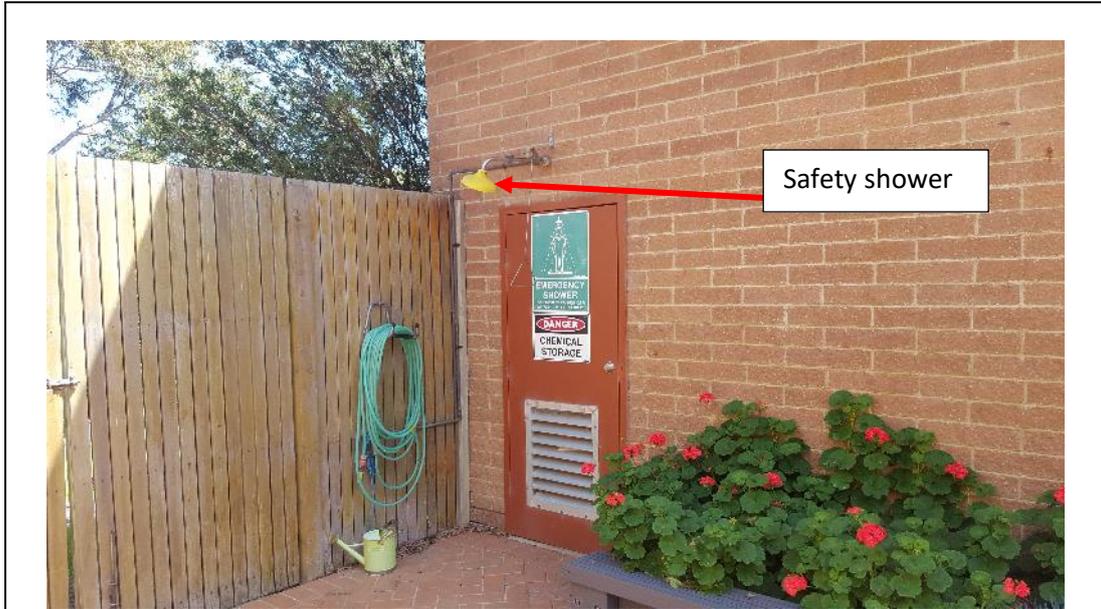
The Sodium Hypochlorite storage tank is in a small separate room adjacent to the plantroom. While there is a large viewing window from the plantroom, the actual access door to this room is external from the outside as this is for the filling operation. See **Images 19, 20 & 21**.

The tank volume is 950 litres. The bund is of masonry construction with a solid plastic liner which measures 1.5m x 1.35m x 1.0m deep. Thus, the bund volume calculates to 2m³, well above the minimum for the tank size.

Image 19. Sodium hypochlorite tank storage room. External access door / fill point.

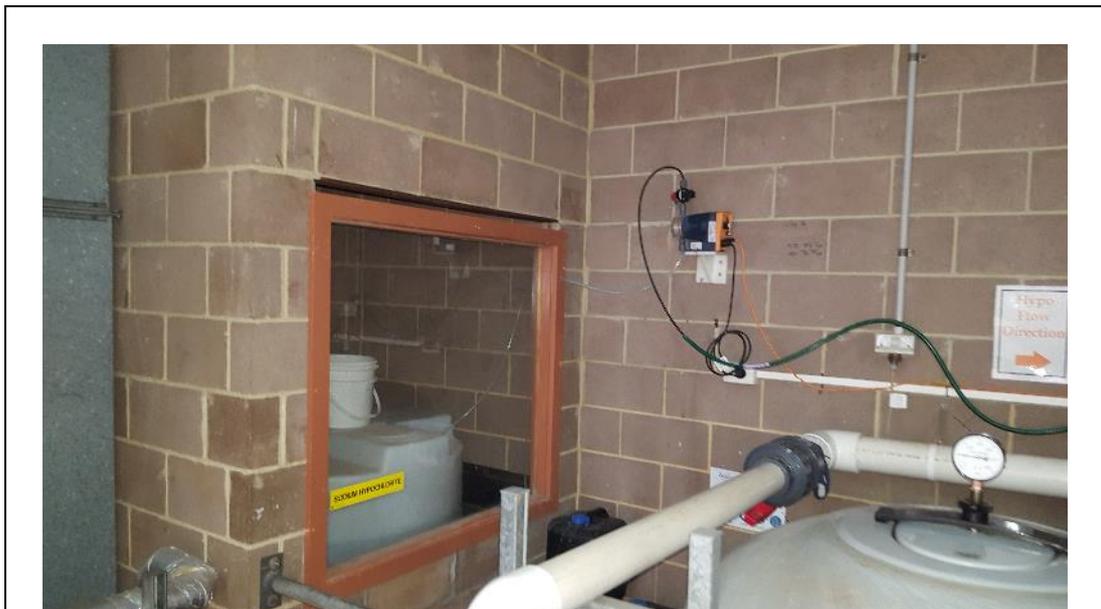
Image 20. Sodium hypochlorite tank storage room. Viewing glass.

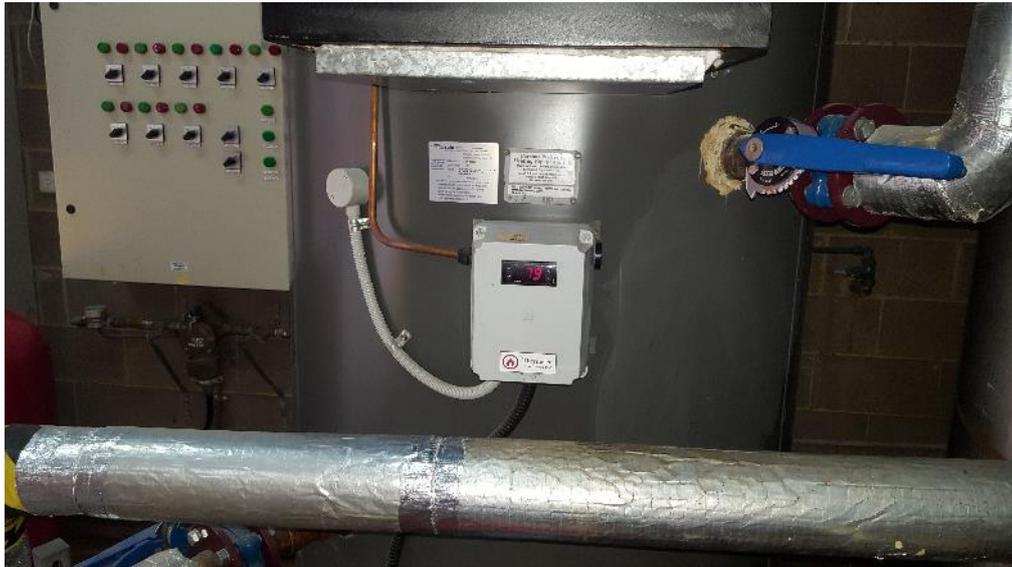
Image 22. Gas Boiler.

The two boilers and HEX are quite new, all being installed in 2015. Their design life can thus be expected to exceed the 10-year time frame being considered for this review.

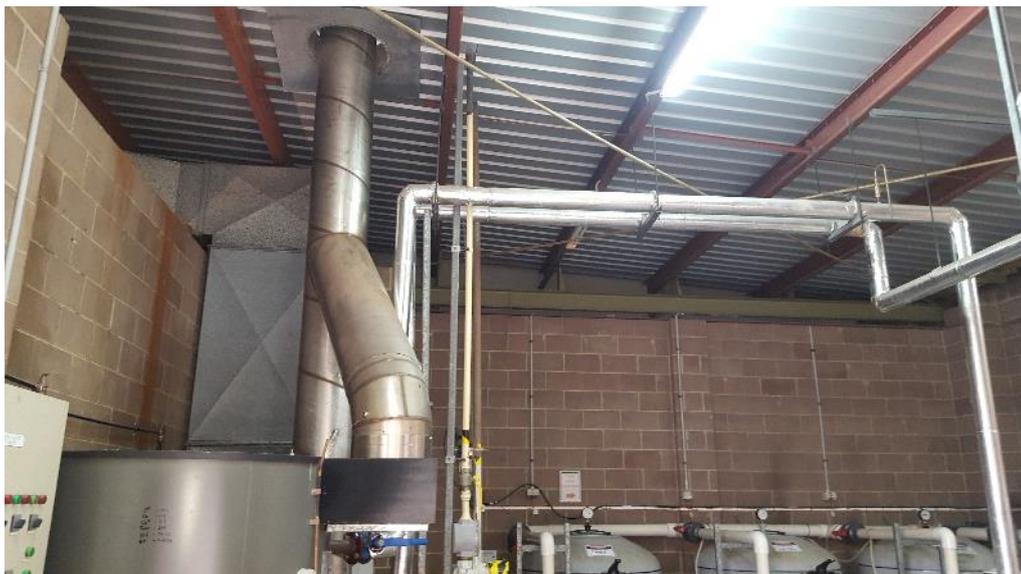
Image 23. Gas boiler and flue / heating loop pipework arrangement.

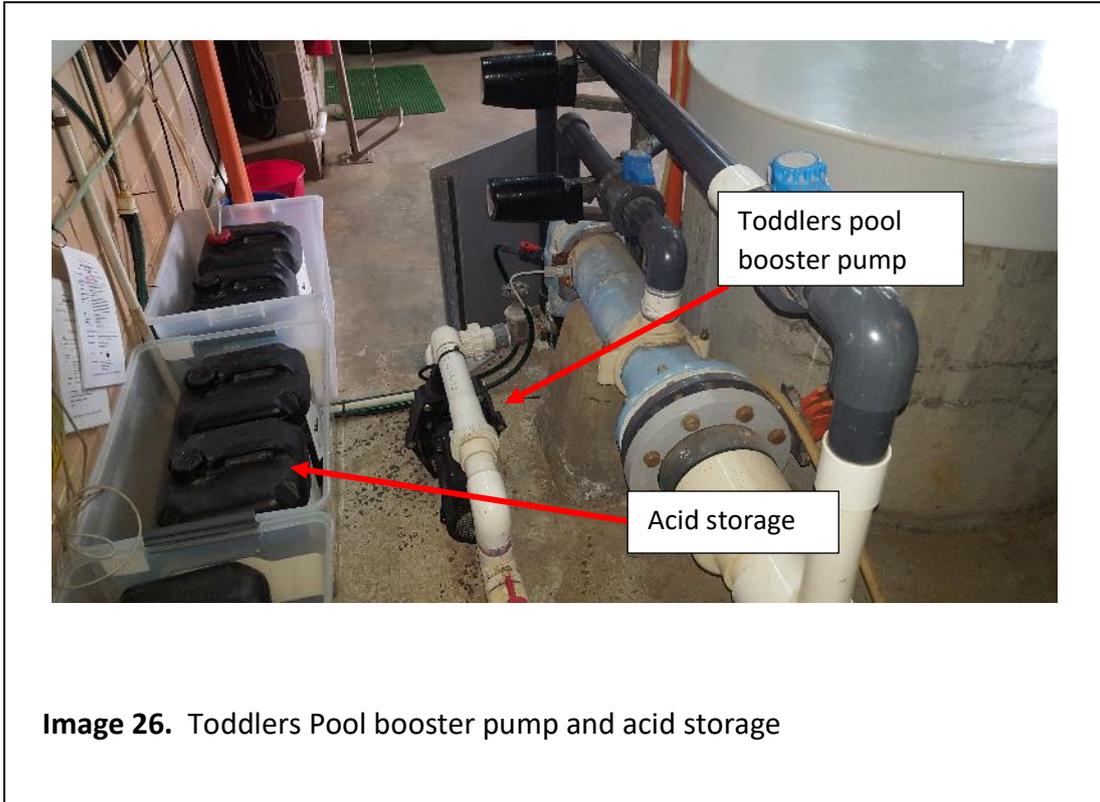
The hydrochloric acid is stored in the plantroom in several 15 litre containers on the floor beneath the dosing controllers. It is well away from the sodium hypochlorite as is necessary and required for safety (mixed together they form toxic chlorine gas). Each pair of

containers is housed within a larger plastic container which serves as the necessary bund for spill containment. See **Image 26**.

Image 26. Toddlers Pool booster pump and acid storage
